**EXAMPLE
REPORT**

Thermographic Survey

Sample Report 4

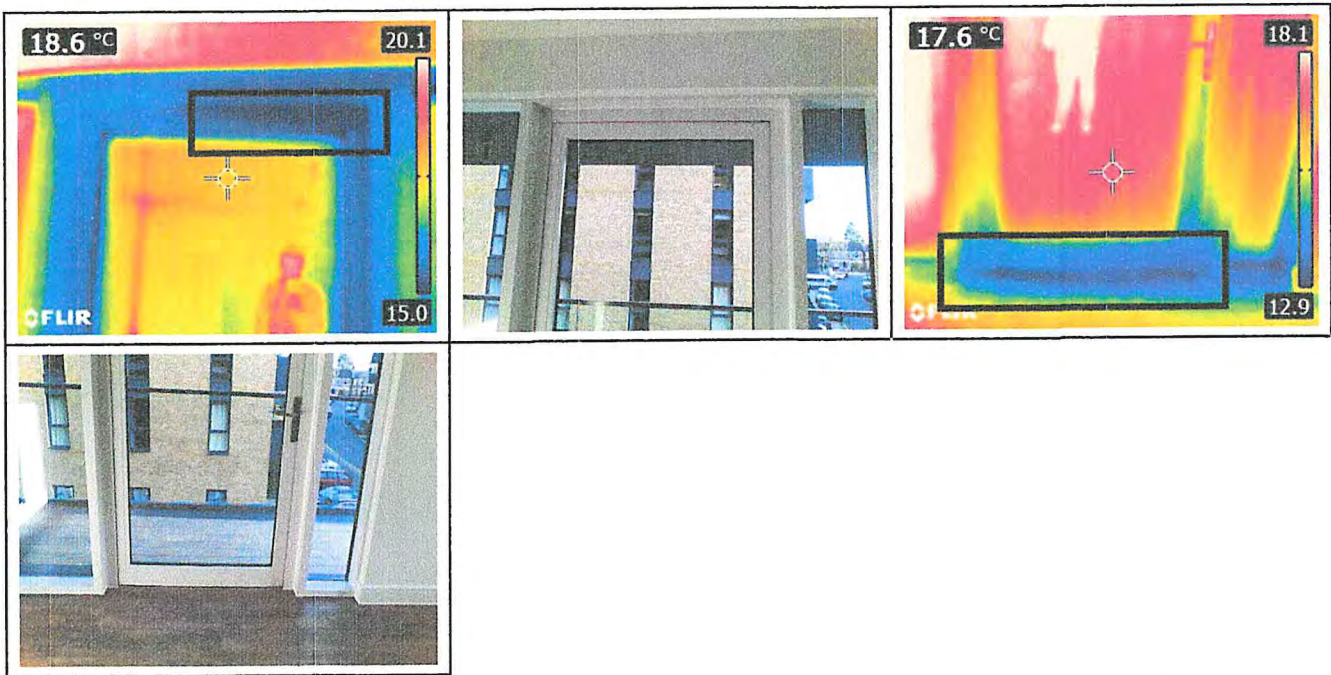
Balcony door

The balcony doors within the living room are showing two notable issues allowing cold air to penetrate from the external leaf. Firstly, the head of the door to the frame is showing a noticeable gap approximately 7mm wide. This gap is allowing a noticeable amount of cold air penetration due to the seal between the door and frame being incomplete. Secondly, the foot of the door along the threshold is also showing penetration, meaning the seal is inadequate between the door and threshold. This issue combined with issue 1 would suggest the door has dropped from it's hinge.

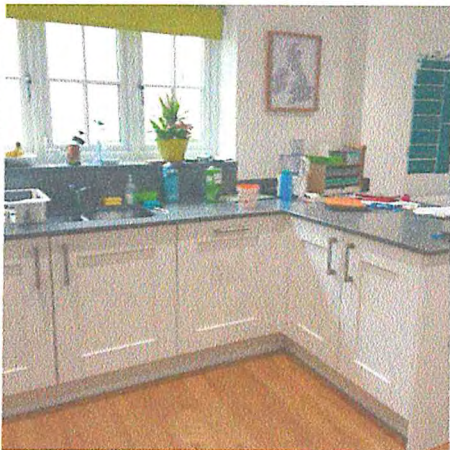
<p>Sink base unit doors misaligned</p>	<input type="checkbox"/>

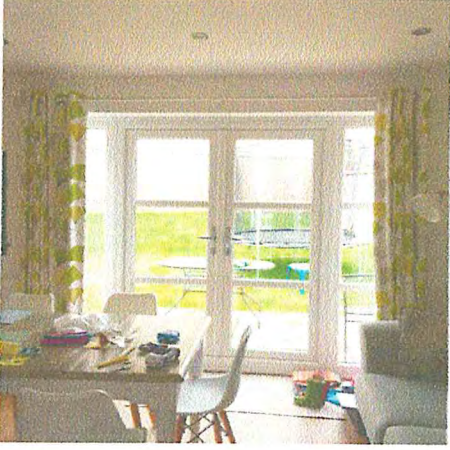
<p>Inadequate finish to decoration to RH skirting return</p>	<input type="checkbox"/>

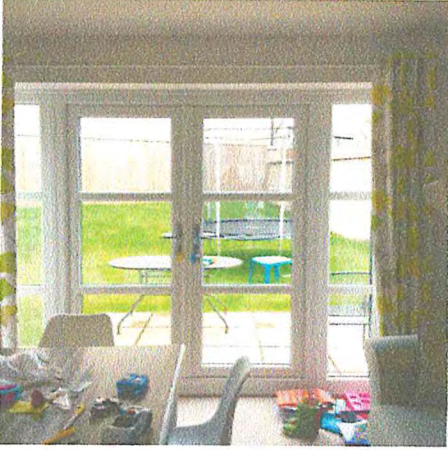
<p>Inadequate finish to decoration to RH skirting return</p>	<input type="checkbox"/>

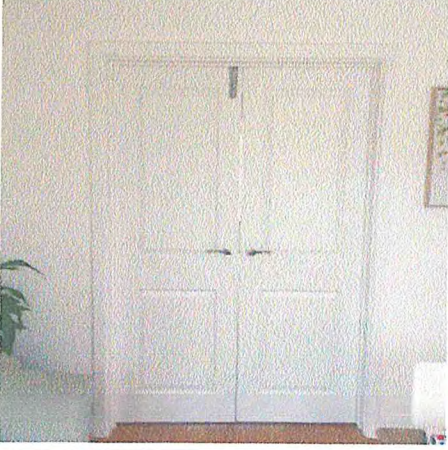
<p>Inconsistent finish to decoration to RH architrave mitre</p>	<input type="checkbox"/>

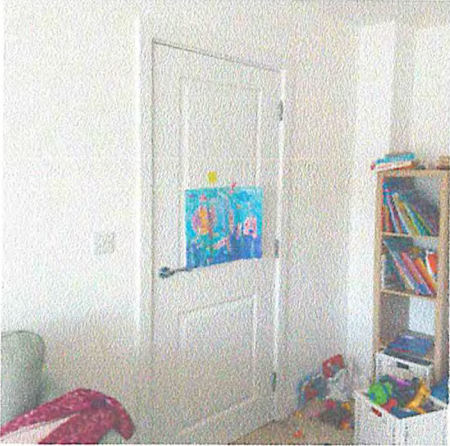
Door not latching correctly	<input type="checkbox"/>
	<hr/>

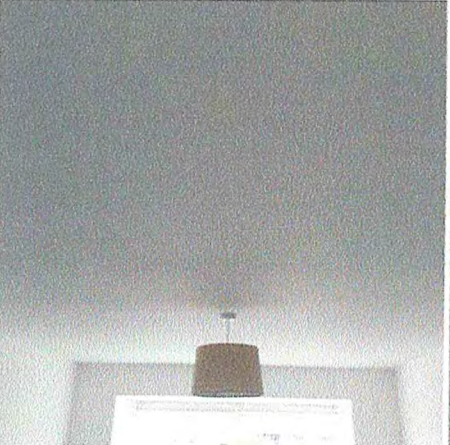
Board joints visible to ceiling area and generally uneven	<input type="checkbox"/>
	<hr/>
