**EXAMPLE
REPORT**

GARDENS

PLOT 62

2022-01-30 16:42:08 / Report Code : eehqwmur

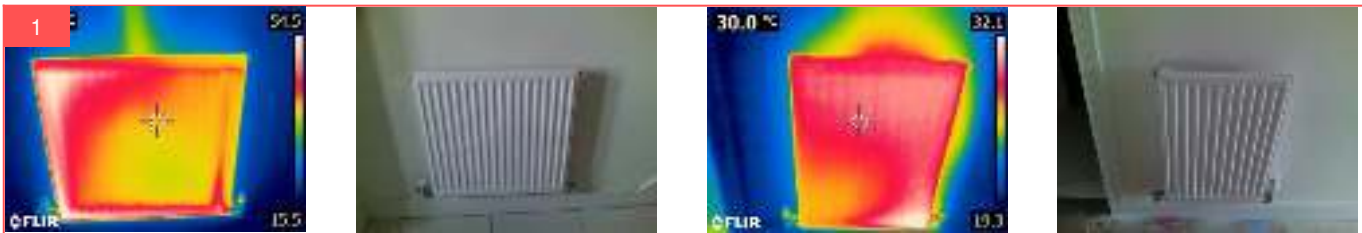
Thermal- Radiators

Description: The radiators to the hallway, utility, and landing are not heating to their maximum potential and may require an adjustment such as bleeding. As indicated on the TIs, various radiators were showing inconsistent temperature readings. Therefore, suggesting thorough testing of the heating system (mechanically and electrically) including zone valves, inlet valves, TRVs, and thermostats to radiators as required to ensure that the system is running efficiently.
