EXAMPLE
REPORT

HOME SNAGGING UK

GARDENS

PLOT 62

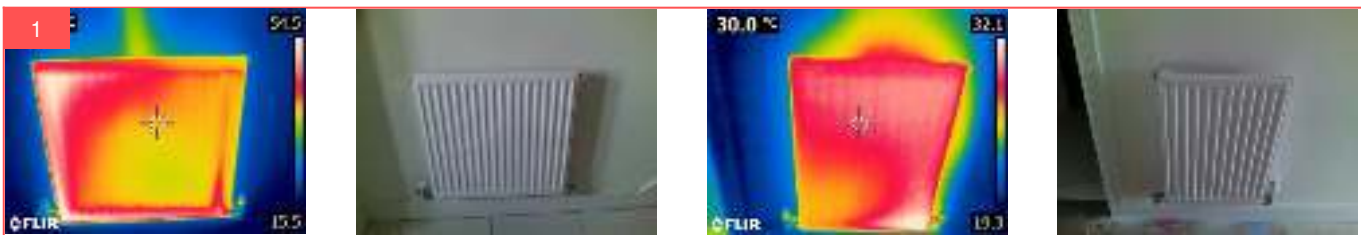
Thermal- Radiators

Description: The radiators to the hallway, utility, and landing are not heating to their maximum potential and may require an adjustment such as bleeding. As indicated on the TIs, various radiators were showing inconsistent temperature readings. Therefore, suggesting thorough testing of the heating system (mechanically and electrically) including zone valves, inlet valves, TRVs, and thermostats to radiators as required to ensure that the system is running efficiently.

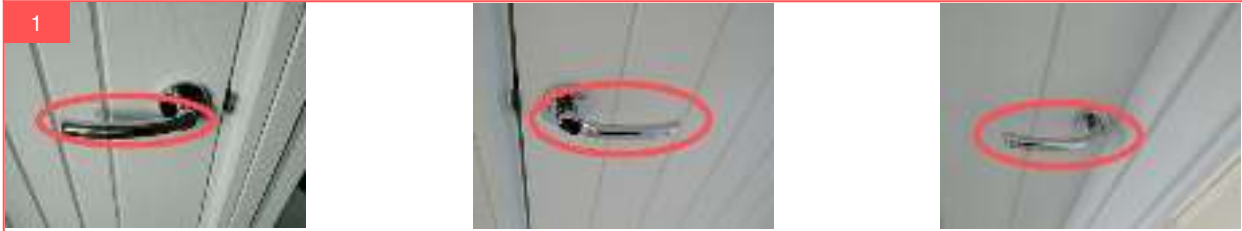
1

Description: Various door handles loose

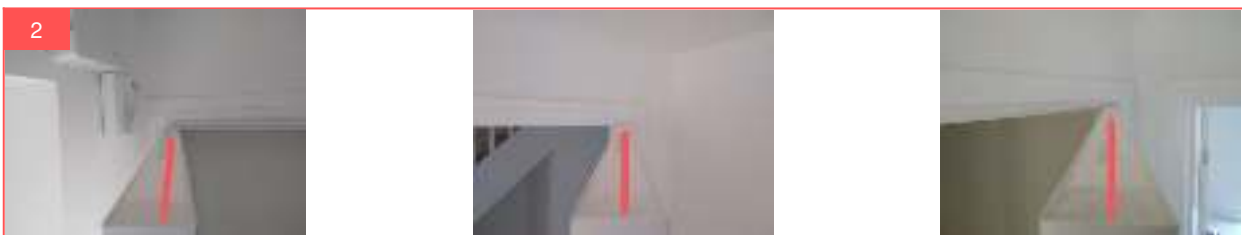
2

Description: Tops of doors not painted

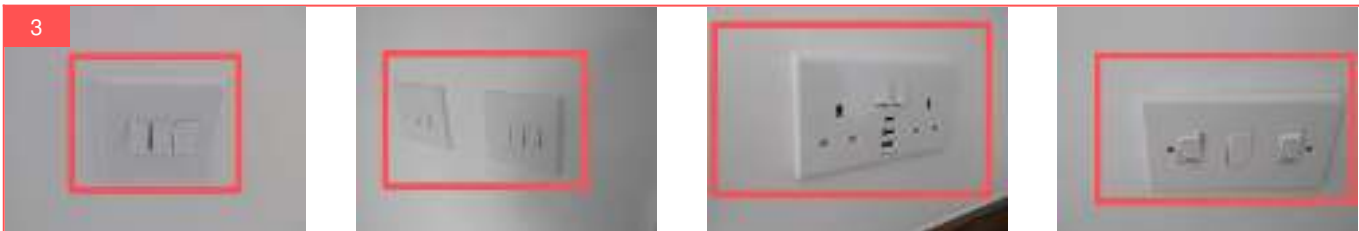
3

Description: Inconsistent finish to decoration around numerous wall components

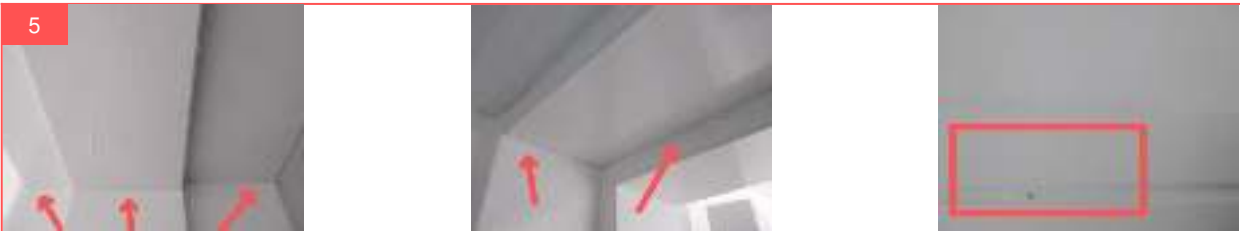
5

Description: Inadequate finish to decoration to numerous door frames

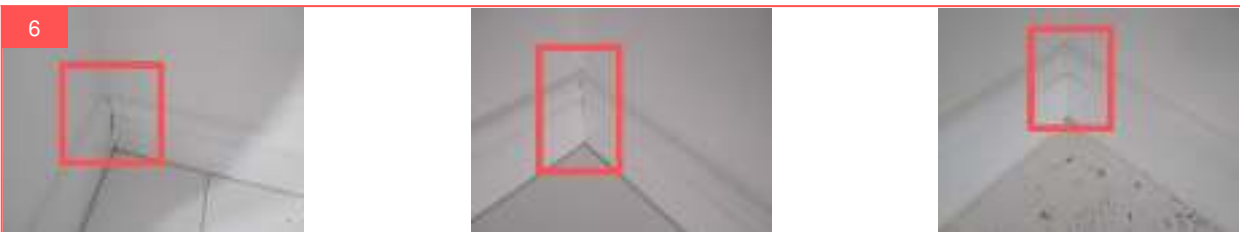
6

Description: Inadequate finish to decoration to various skirtings

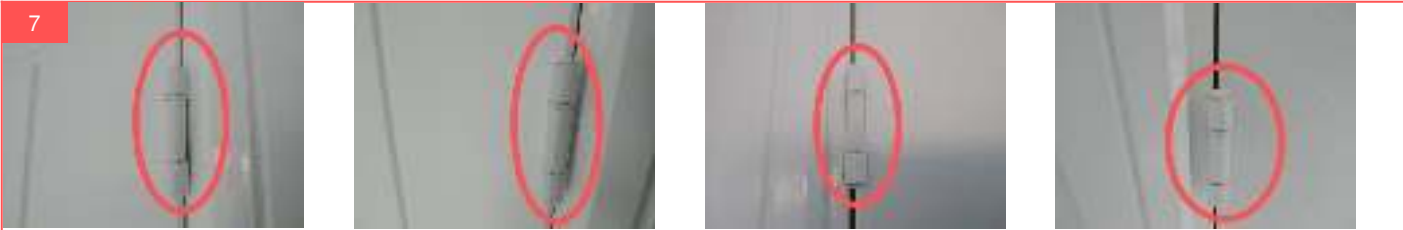
7

Description: Door hinges over-painted
