Keith Reed
Home Snagging UK

COSELEY NEW VILLAGE

Plot 37

Sunday, 17 December 2023

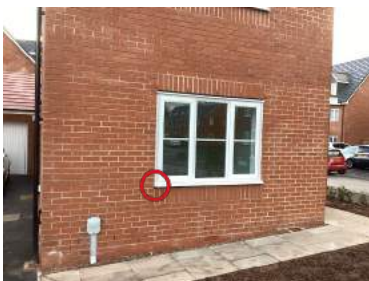
FRONT ELEVATION

Inconsistent finish to pointing to several areas of brickwork

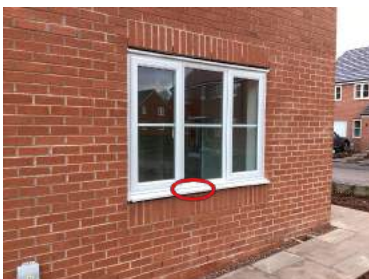
FRONT ELEVATION

Inadequate finish to mastic seal to lounge window frame perimeter

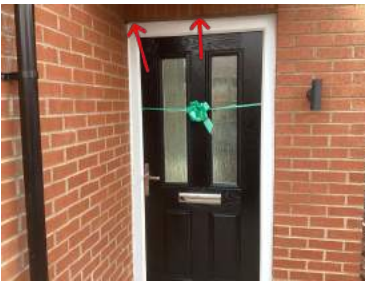
FRONT ELEVATION

Inadequate finish to mastic seal to front door frame perimeter

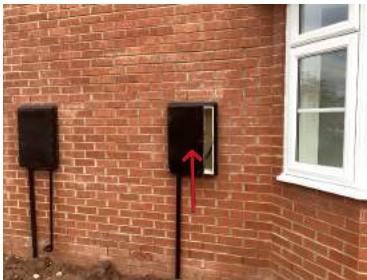
RIGHT ELEVATION

Inadequate finish around pipe penetration

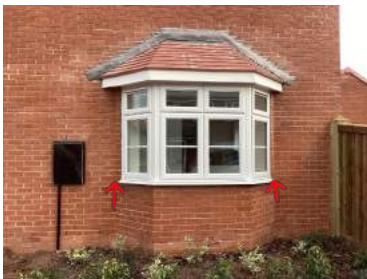
RIGHT ELEVATION

Chipped brick below window

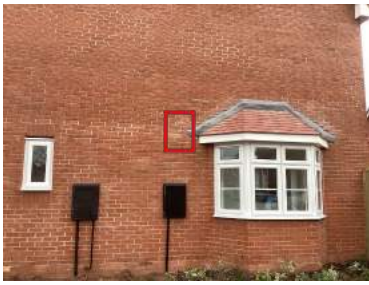
RIGHT ELEVATION

Bay window cill end caps missing

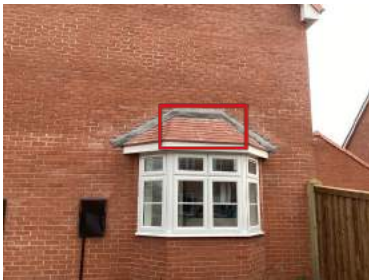
RIGHT ELEVATION

Bay window GRP roof damaged on corner

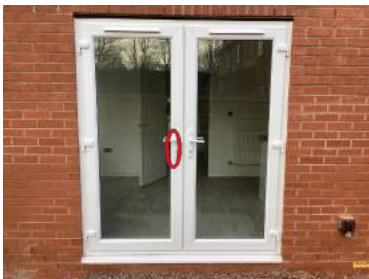
REAR ELEVATION

Inconsistent finish to mastic seal to French door frame perimeter

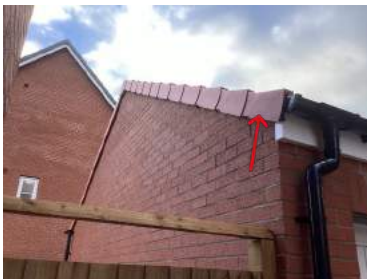
GARAGE

Brickwork missing below dry verge

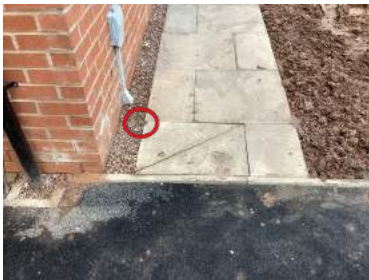
GARDEN
Paving slab cracked

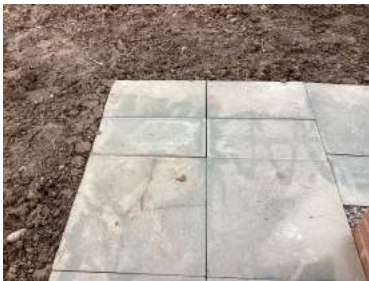
GARDEN
Paving slab chipped

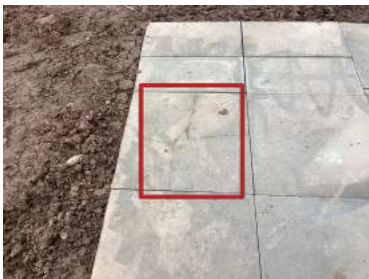
GARDEN
Paving slabs loose and not tight together

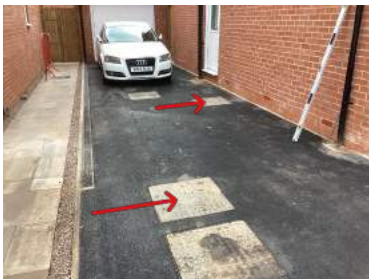
GARDEN
Paving slab cracked

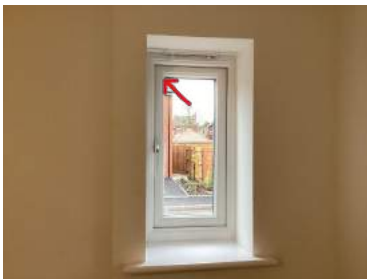
HALLWAY

Inadequate finish to decoration to window reveals

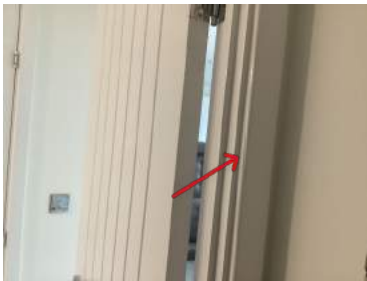
HALLWAY

Variable finish to decoration around bottom of newel post

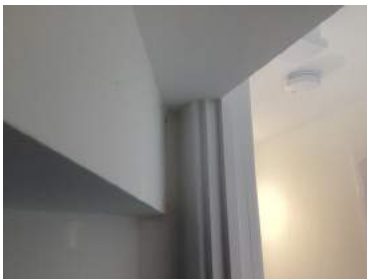
UNDER STAIRS CUPBOARD

Architrave damaged

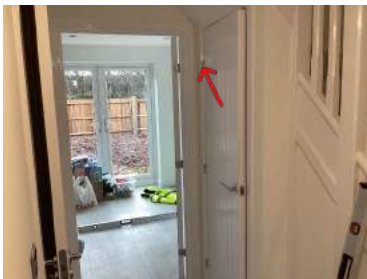
UNDER STAIRS CUPBOARD

Inadequate finish to decoration to wall areas around architraves inside under stairs cupboard

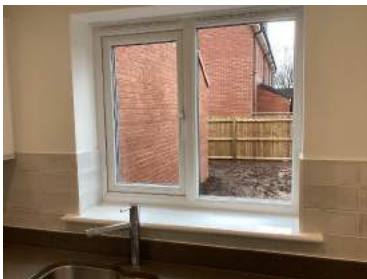
KITCHEN

Manufacturing fault to glazed unit

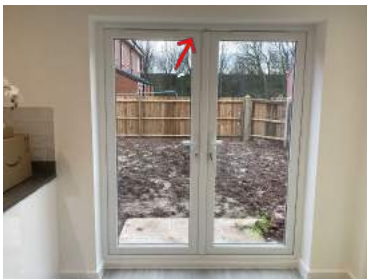
DINING ROOM

French door set glazed units scratched

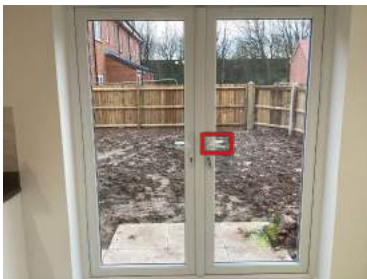
DINING ROOM

Glazing bead broken

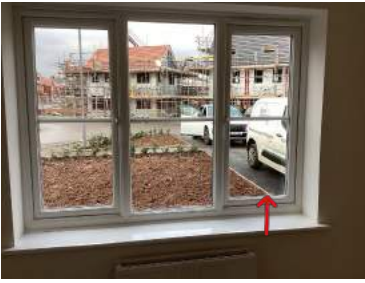
LOUNGE

Variable finish to decoration to window reveals

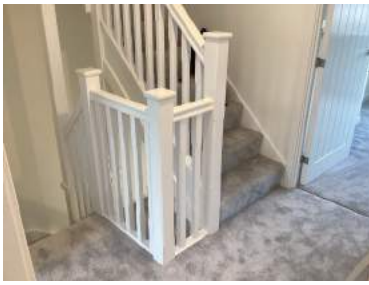
STAIRS

Inadequate finish to decoration and plastering to various parts of bulkhead

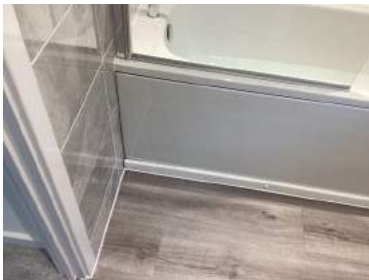
BATHROOM

Shower hose rail loose

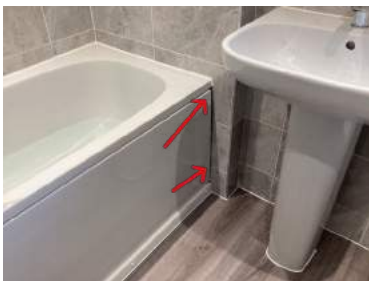
BATHROOM

Screw cap missing

Inadequate finish to decoration to timber below bath panel

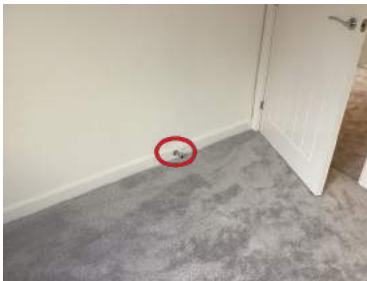
EN SUITE 2

No door stop fitted

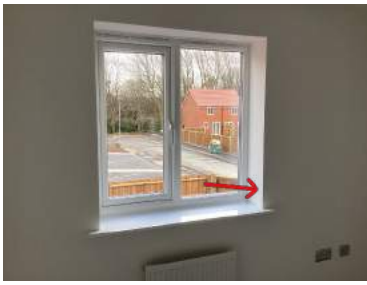
BEDROOM 3

Window board is water damaged

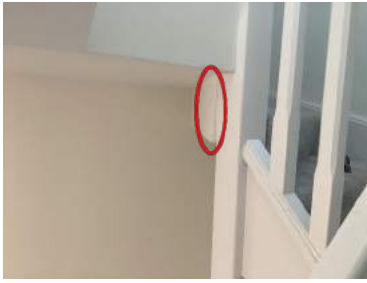
STAIRS 2

Inadequate finish to decoration to newel post

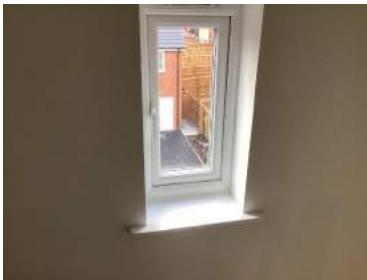
STAIRS 2

Stairs 2 window board not level

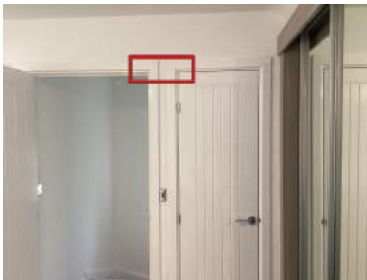
BEDROOM 1

Variable finish to plastering to wall area between architraves

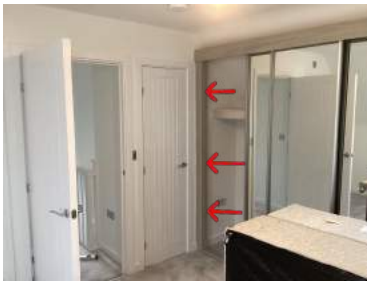
BEDROOM 1

Inadequate finish to decoration to architraves

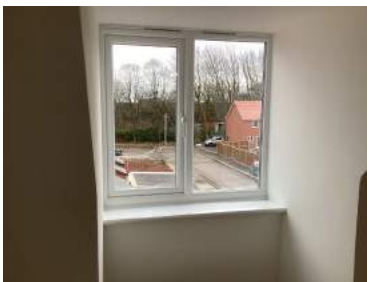
BEDROOM 1

Window board not level

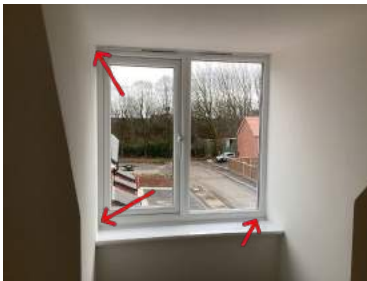
BEDROOM 1

Window board water damaged

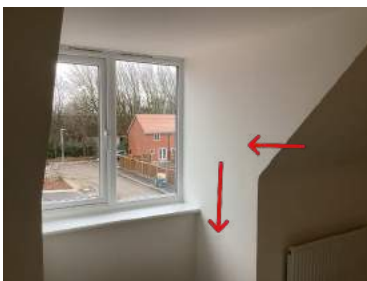
BEDROOM 1

Inadequate finish to mastic seal to window frame perimeter

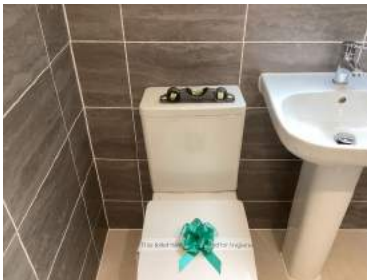
EN SUITE 1

Inadequate finish around pipe penetrations behind basin and WC

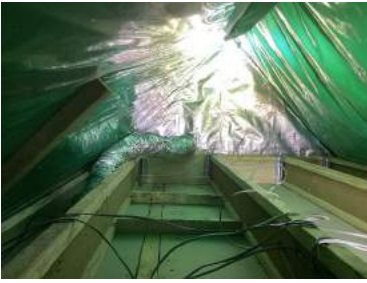
EN SUITE 1

Access hatch cover cap missing
