Keith Reed
Home Snagging UK

COSELEY NEW VILLAGE

Plot 37

Sunday, 17 December 2023

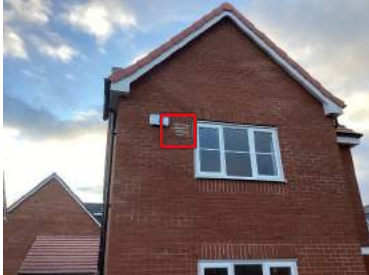
FRONT ELEVATION

Different coloured mortar used to pointing

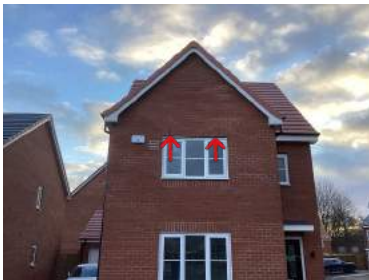
FRONT ELEVATION

Brickwork above lintel not level

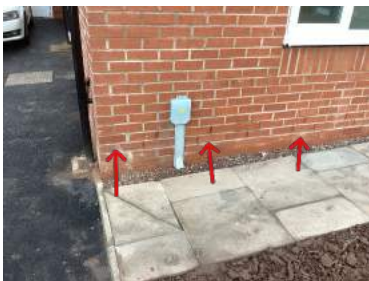
FRONT ELEVATION

Inconsistent finish to pointing to several areas of brickwork

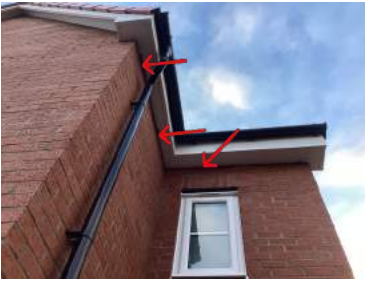
FRONT ELEVATION

DPC not trimmed to top of brickwork

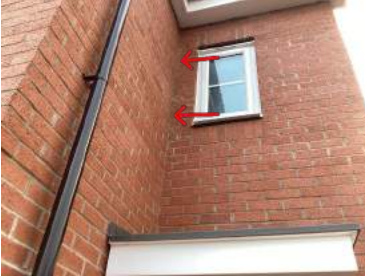
FRONT ELEVATION

Variable finish to brickwork, perp joints excessive

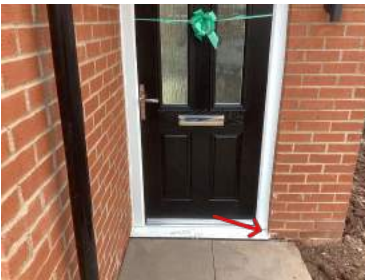
FRONT ELEVATION

Inadequate finish to mastic seal to front door frame perimeter

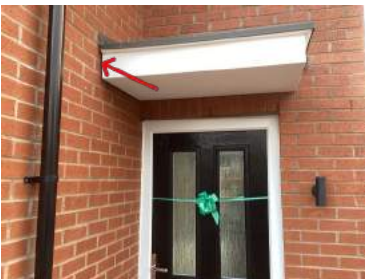
FRONT ELEVATION

Front door canopy not fitted tight up to brickwork

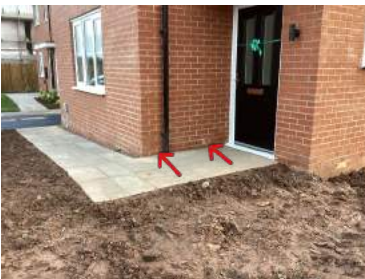
FRONT ELEVATION

Paving slabs same level as FFL, should be 150mm clearance

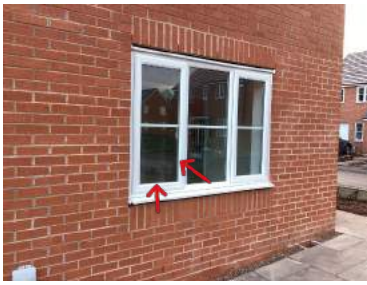
FRONT ELEVATION

Lounge window frame scratched

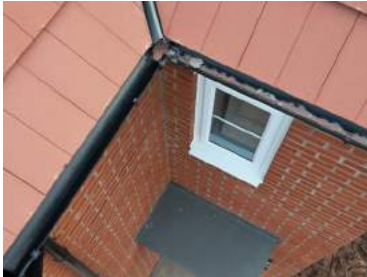
FRONT ELEVATION

Debris not removed from guttering

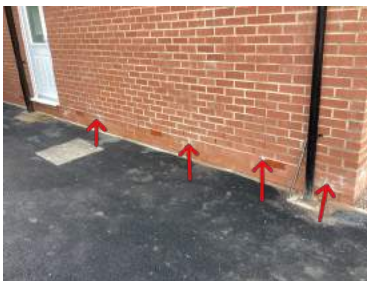
LEFT ELEVATION

Different coloured mortar used in several areas

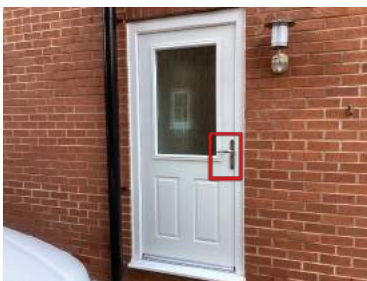
LEFT ELEVATION

Sticky residue not cleaned from back door handle

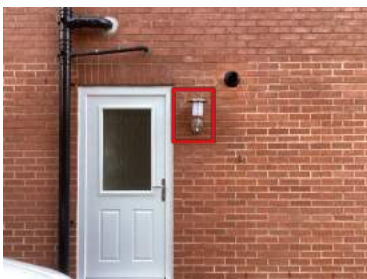
LEFT ELEVATION

Outside light not level

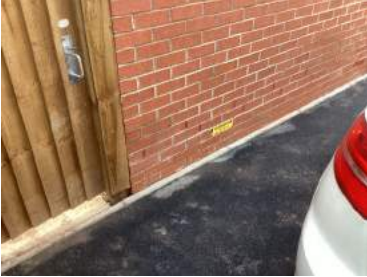
LEFT ELEVATION

Protection tape not removed from air brick

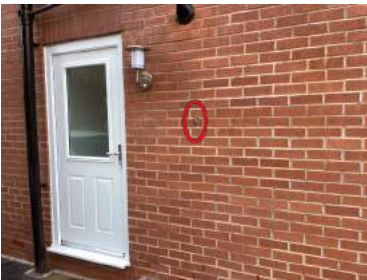
LEFT ELEVATION

No mastic seal to blow off pipe penetration

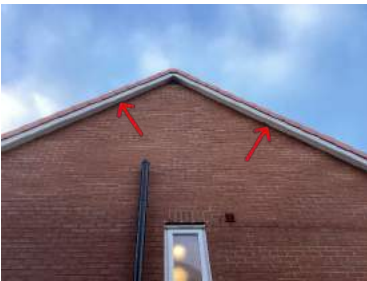
LEFT ELEVATION

Soffit board not cleaned

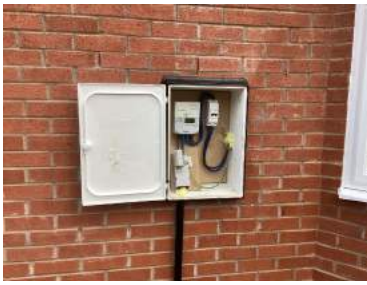
RIGHT ELEVATION

Electric service cabinet not adequately sealed

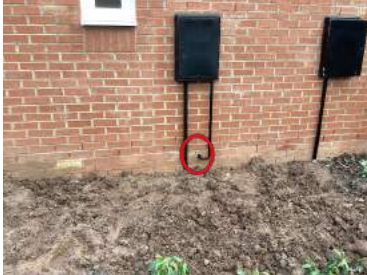
RIGHT ELEVATION

Inadequate finish around pipe penetration

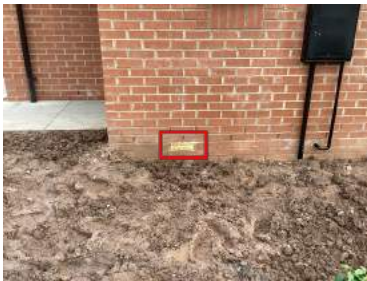
RIGHT ELEVATION

Protection tape not removed from air brick

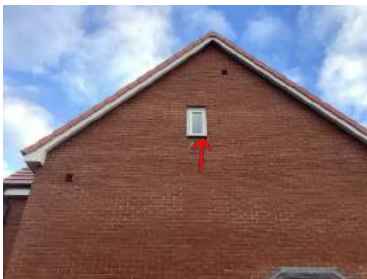
RIGHT ELEVATION

Chipped brick below window

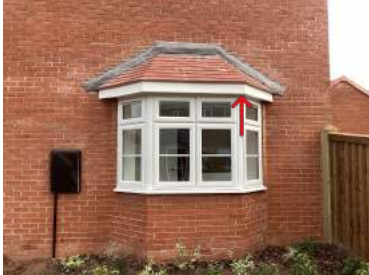
RIGHT ELEVATION

Bay window GRP roof damaged on corner

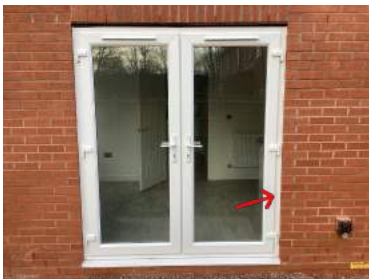
REAR ELEVATION

Inconsistent finish to mastic seal to French door frame perimeter

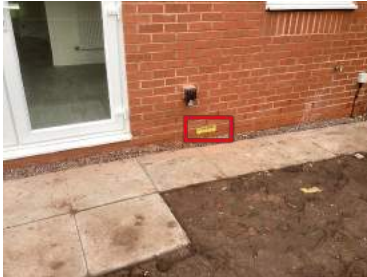
REAR ELEVATION

Protection tape not removed from air brick

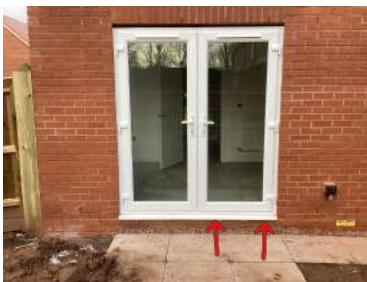
REAR ELEVATION

Mastic seal to underside of French doorset threshold incomplete

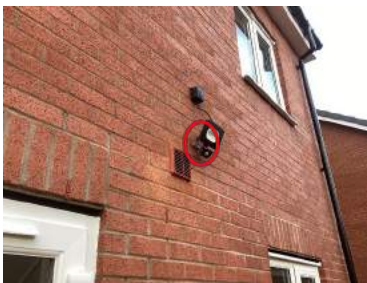
REAR ELEVATION

Outside light not cleaned

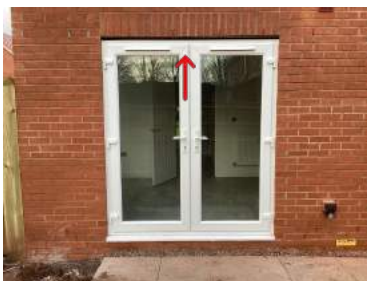
REAR ELEVATION

French door set door scratched

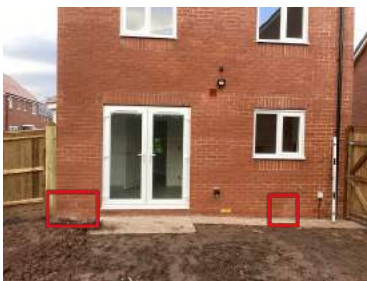
REAR ELEVATION

Areas of brickwork not cleaned

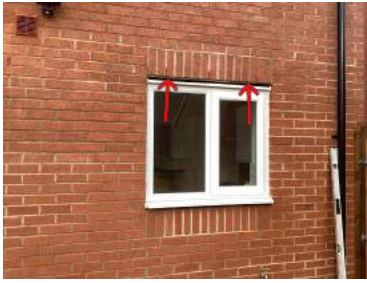
REAR ELEVATION

Inconsistent finish to pointing to kitchen window lintel

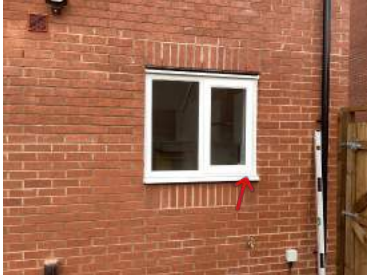
REAR ELEVATION

Kitchen window cill scratched

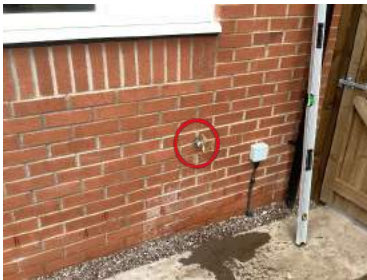
REAR ELEVATION

Outside tap not fully secured

Variable finish to pointing behind outside tap

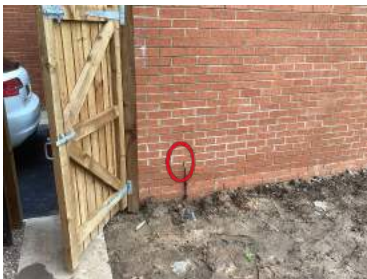
GARAGE

Cable penetration not sealed

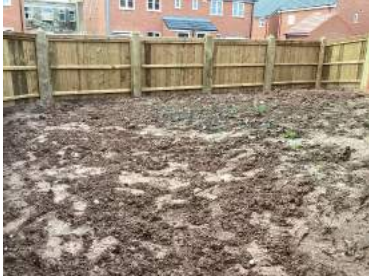
GARDEN

Rear garden not rotorvated

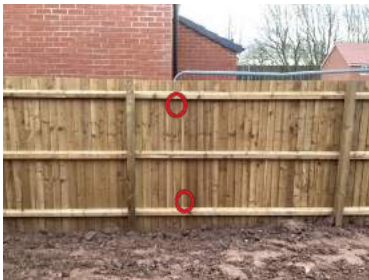
GARDEN

Screws protruding from fence

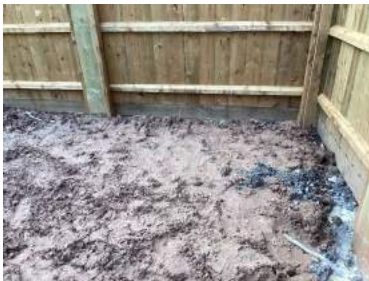
GARDEN

Topsoil not level up to fence

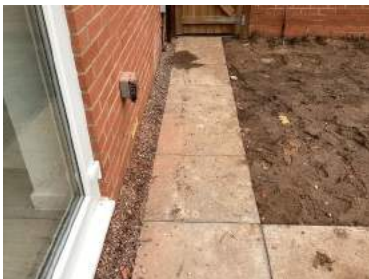
GARDEN

Paving slabs not cleaned

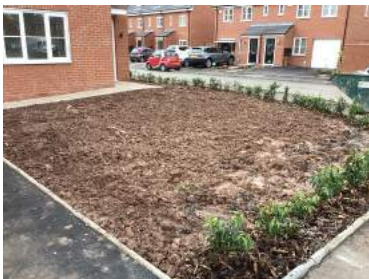
GARDEN

Landscaping to front garden not complete

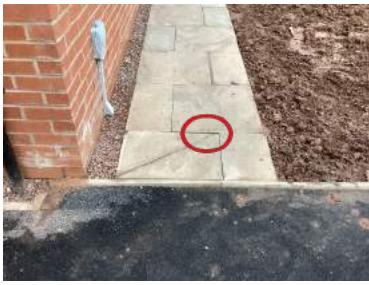
GARDEN
Paving slabs uneven

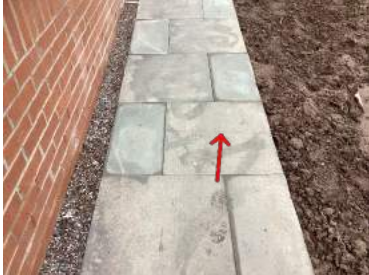
GARDEN
Paving slab cracked

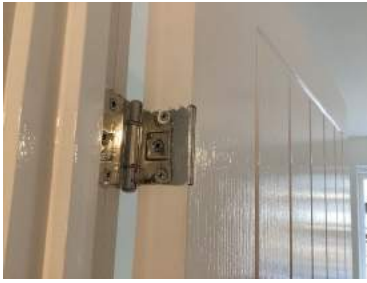
GENERAL

Chrome hinges overpainted in several locations

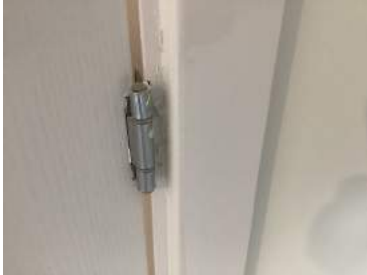
GENERAL

Inconsistent finish to decoration behind hinges in various locations

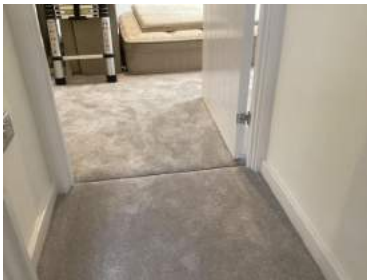
GENERAL

Carpets marked in various rooms, builder to check

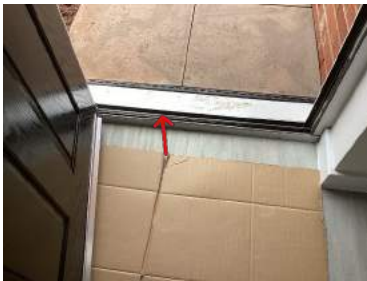
HALLWAY

Mortar debris not cleaned from front door threshold

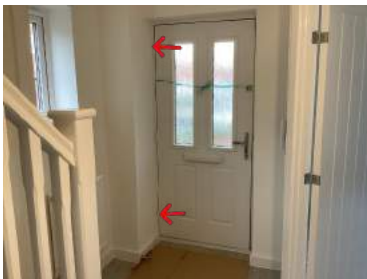
HALLWAY

Front door hinges not parallel to reveal

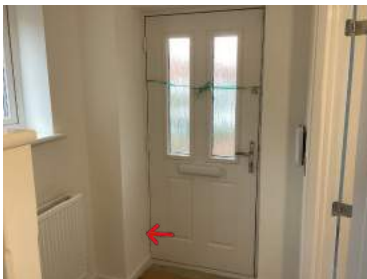
HALLWAY

No mastic seal to front door frame perimeter behind bottom hinge

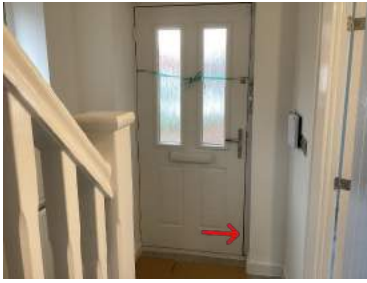
HALLWAY

Excessive door margin, front door not touching brush strip

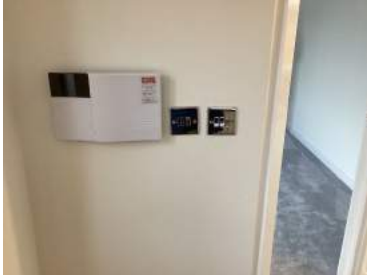
HALLWAY

Wall components not level

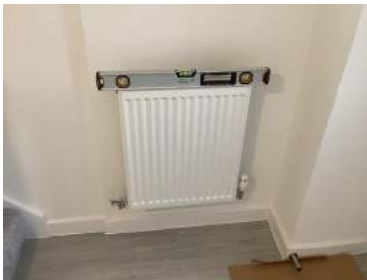
HALLWAY

Radiator not level

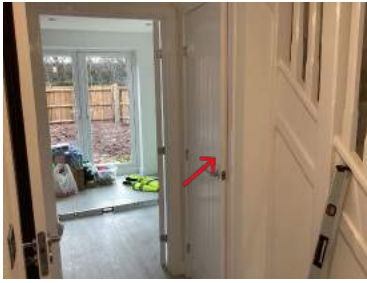
HALLWAY

Variable finish to decoration to door panels

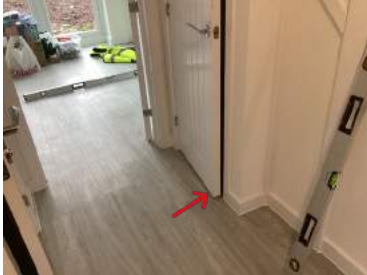
HALLWAY

Bottom edge of under stairs cupboard door damaged

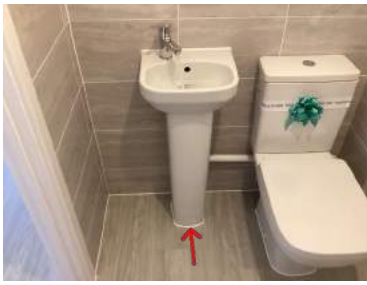
WC

Pedestal not fitted squarely

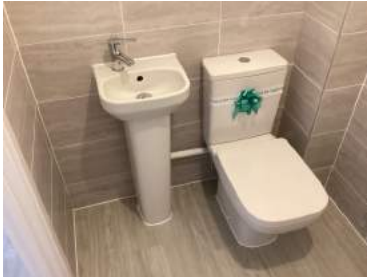
Inadequate finish to tiling around pipe penetrations to WC and basin

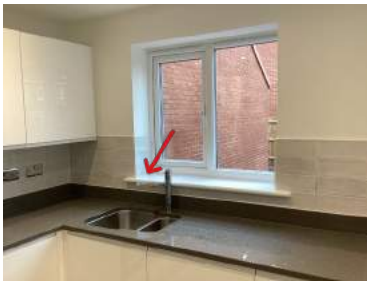
KITCHEN

Excessive grout margin between reveal and window board

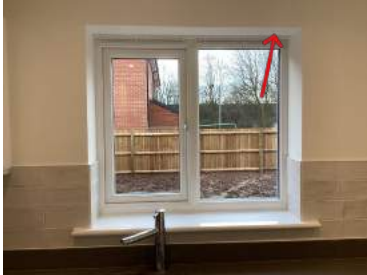
KITCHEN

Variable finish to decoration to window reveals

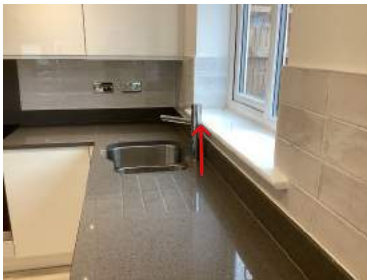
KITCHEN

Kitchen faucet touching window board

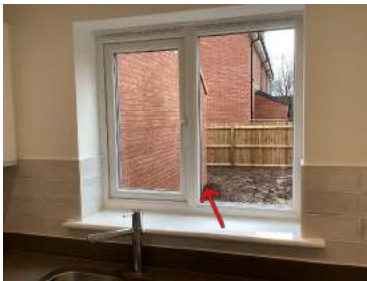
KITCHEN

Manufacturing fault to glazed unit

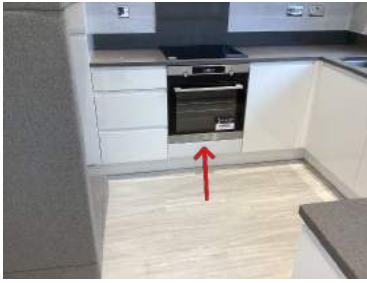
KITCHEN

Panel below oven different colour

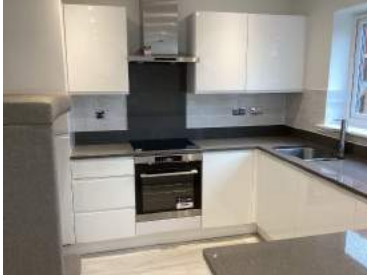
KITCHEN

Kitchen unit doors not aligned

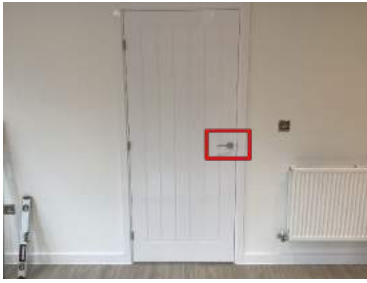
DINING ROOM

Door not latching correctly

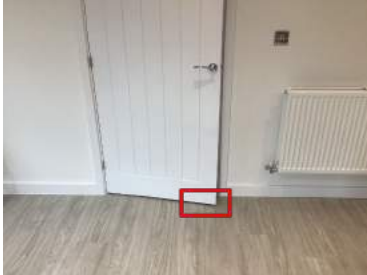
DINING ROOM

Bottom edge of door damaged

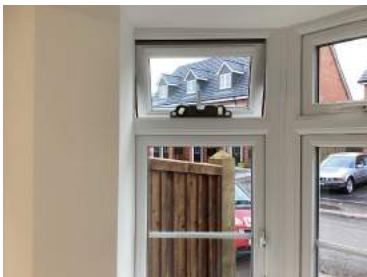
DINING ROOM

Side window not level

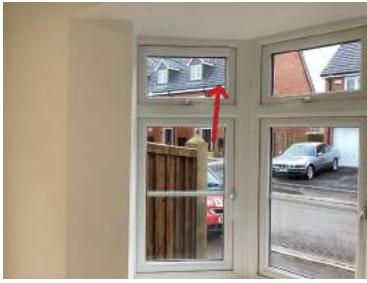
DINING ROOM

Mark on inside of glazed unit

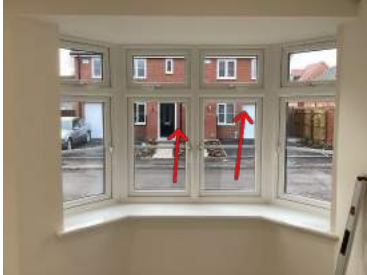
DINING ROOM

Glazed units scratched

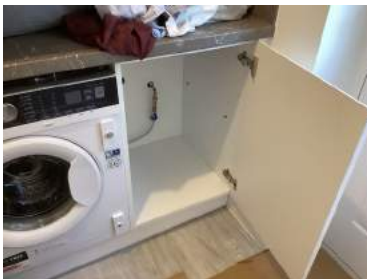
UTILITY

Shelf missing to base unit

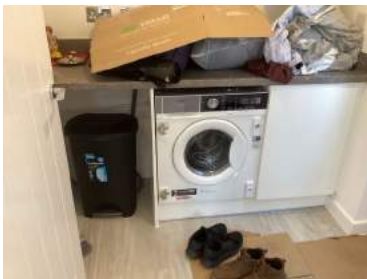
UTILITY

Integrated washing machine door missing

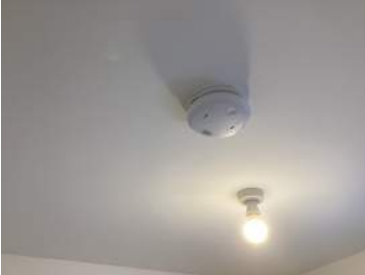
UTILITY

Variable finish to decoration around ceiling components

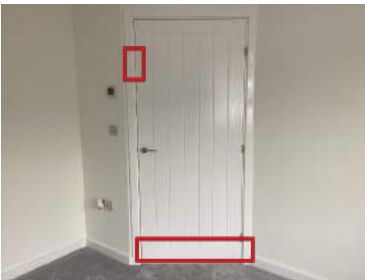
LOUNGE

Inadequate finish to decoration to door panel

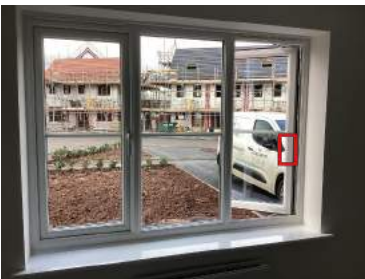
LOUNGE

Window frame marked

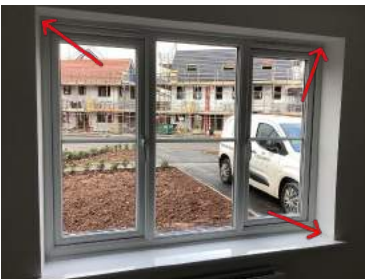
LOUNGE

Variable finish to decoration to window reveals

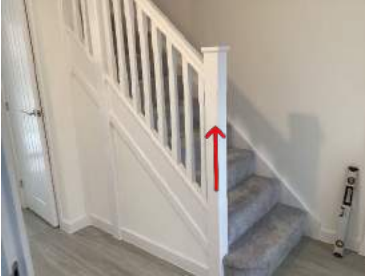
STAIRS

Inconsistent finish to decoration to newel post

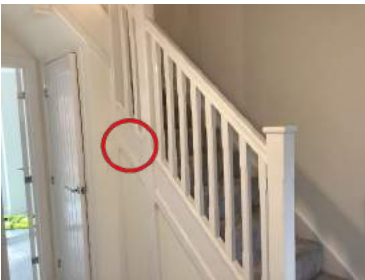
STAIRS

Inconsistent finish to decoration to stair string

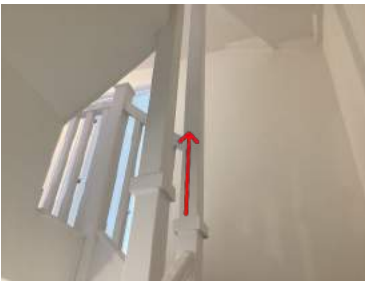
STAIRS

Newel post not plumb

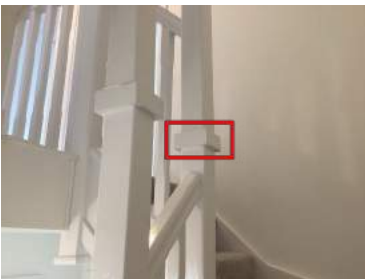
STAIRS

Timber around newel post joint not level

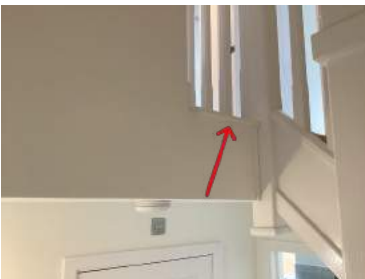
STAIRS

Inadequate finish to decoration and plastering to various parts of bulkhead

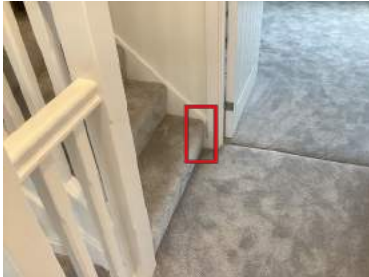
LANDING

Variable finish between stair string and architrave

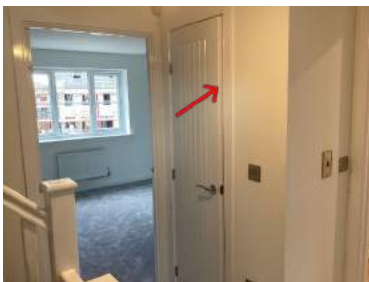
LANDING

Landing cupboard door catching on frame

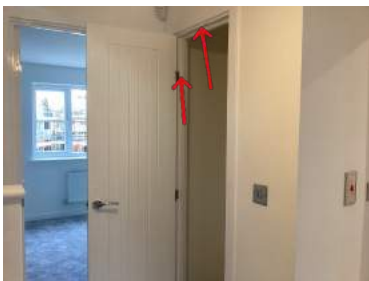
LANDING

Paint chipped to landing cupboard door frame

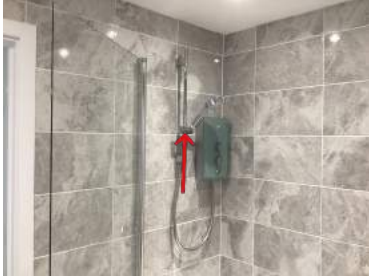
BATHROOM

Inconsistent finish to wall tiling

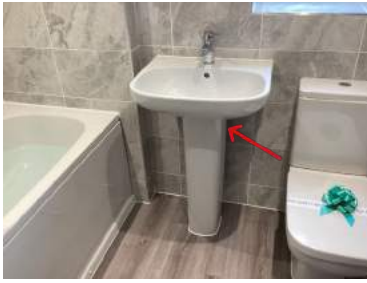
BATHROOM

Corner of wall tile chipped at eye level

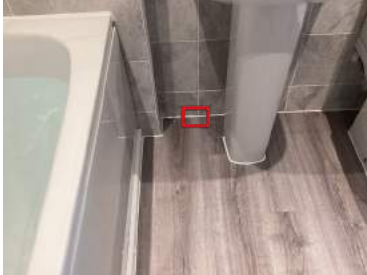
BATHROOM

Inconsistent finish around pipe penetrations behind basin

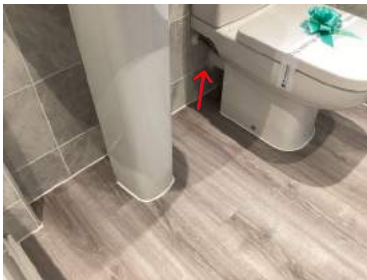
BATHROOM

Grouting incomplete to several areas of tiling

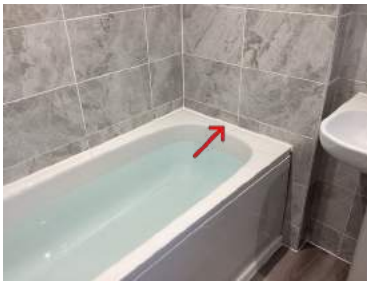
BATHROOM

Variable finish to mastic seal around WC waste pipe

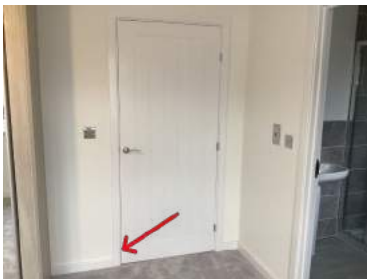
BATHROOM

No door stop fitted

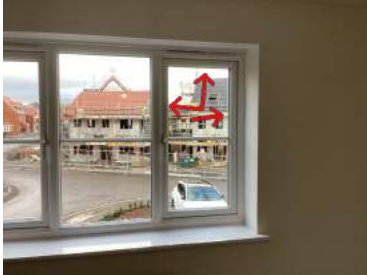
BEDROOM 2

Inadequate finish to decoration to window board

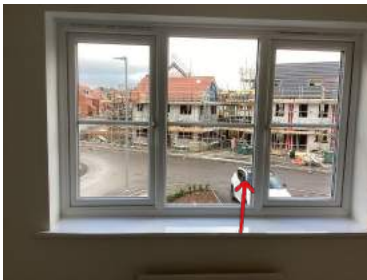
BEDROOM 2

Glazed unit marked

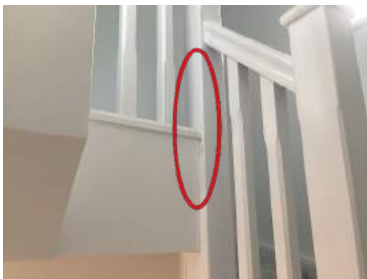
STAIRS 2

Variable finish to plastering to bulkhead areas

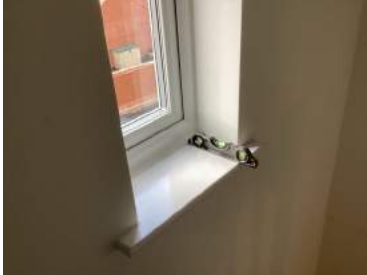
STAIRS 2

Plastering not in line with newel post

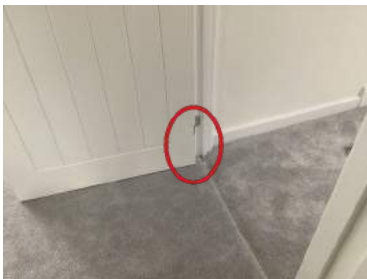
LANDING 2

Imperfections to decoration to various ballustrade components

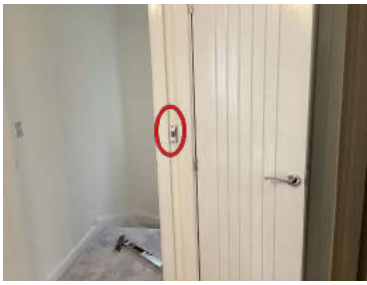
BEDROOM 1

Fire door catching on stop lath and will not close

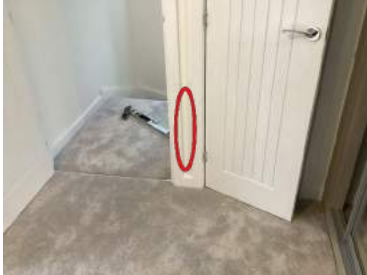
BEDROOM 1

Inconsistent finish to decoration around wall component

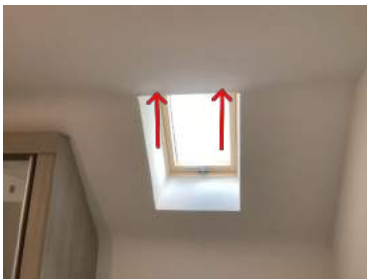
BEDROOM 1

Velux window handle overpainted

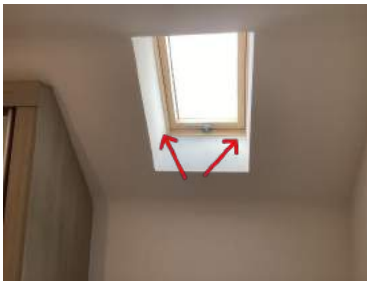
BEDROOM 1

Variable finish to plastering

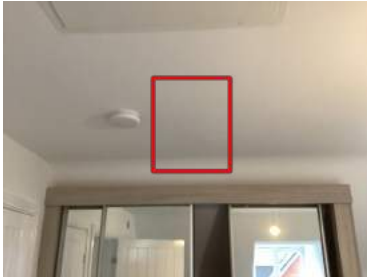
BEDROOM 1

Inadequate finish to plastering around loft hatch

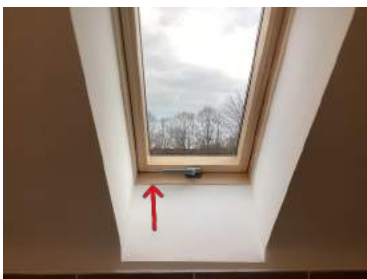
EN SUITE 1

Bottom edge of Velux reveal not level or parallel to tile trim
